# Riverfly Monitoring Newsletter

Southwest Wales

Spring 2014

## Common ID Pitfalls – The slimy legless things!!!

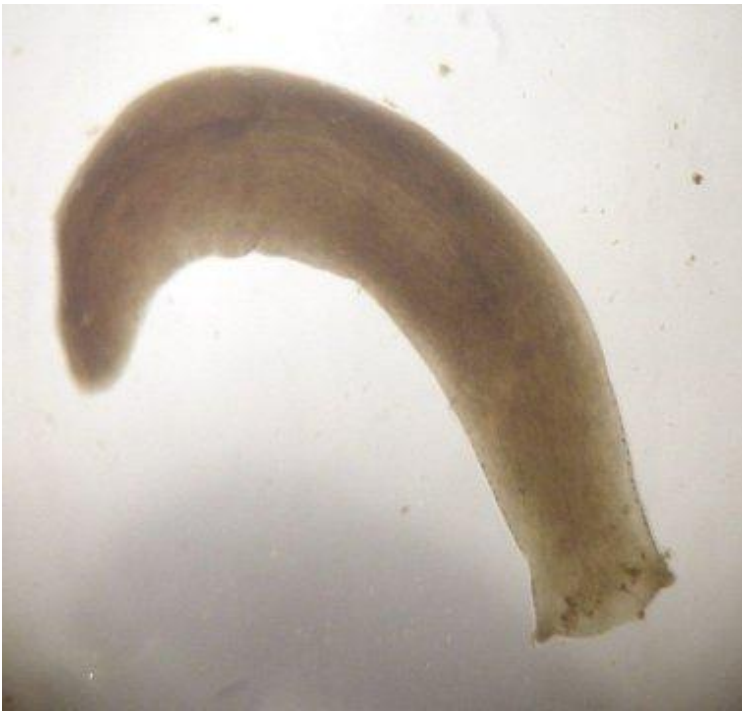
### Flatworms

These are completely flat (as the name suggests!), usually up to about 1cm long and move by gliding about on the bottom of your tray. They have no suckers on either end, and sometimes have two small hornlike projections at the head end. The one in the picture above is *Polycelis felina*, which has two projections a bit like cat ears at the head end. Another species we get is *Dugesia*, an American invader, which has more of a diamond shaped head and is up to 2cm long. We've definitely recorded this at the lower ends of several catchments, so it's one to look out for.

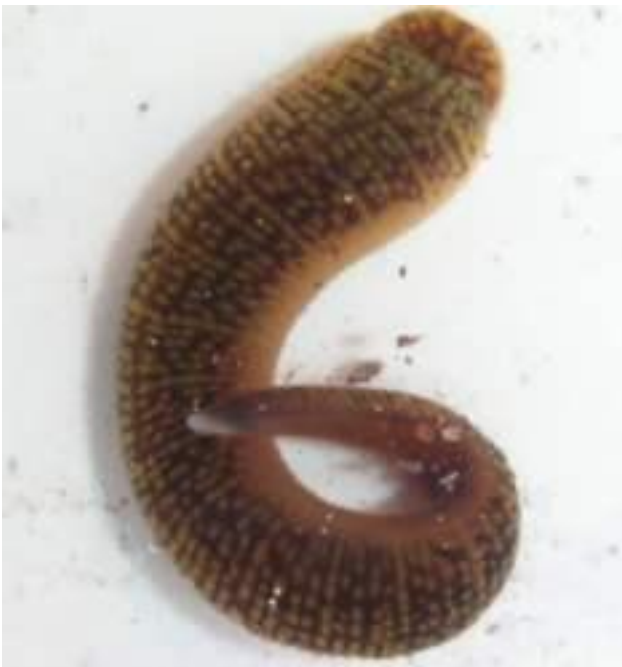
## Leeches

Leeches have suckers at both ends, and are sometimes strikingly marked. They move by attaching and detaching each sucker and stretching from long and thin to short and fat. The species we usually get in our samples vary from 2cm to 5cm long. None of them are harmful to humans and tend to feed on snails. The only British species that is capable of biting a human is the medicinal leech, which is very rare and only found in a handful of lakes.

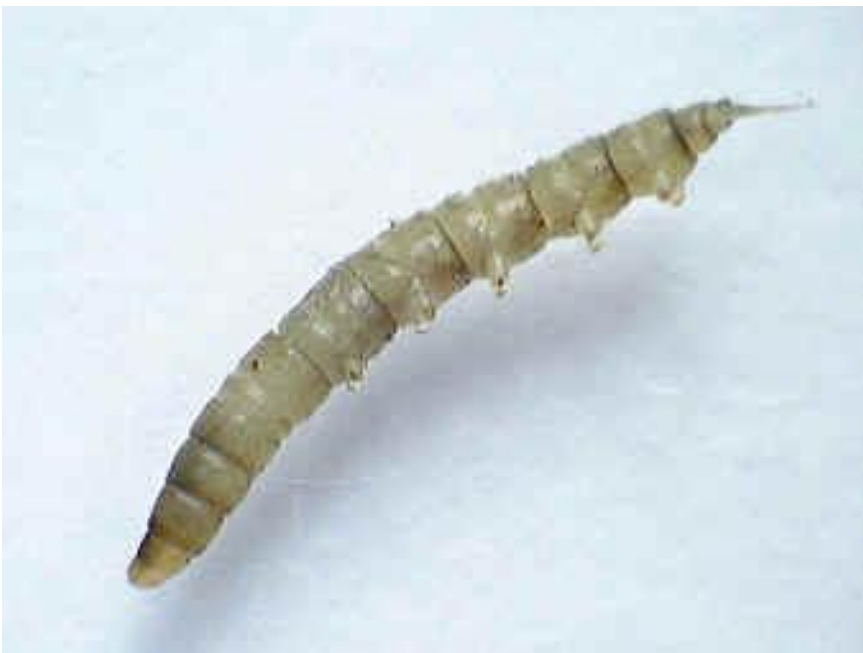
## Cranefly Larvae

These look like aquatic versions of the “Leatherjackets” that you find buried in the soil in gardens. Some have little prolegs and some don’t, and they vary from about 2cm long to 5cm long.
