# Riverfly Monitoring Newsletter

Southwest Wales

Summer 2013

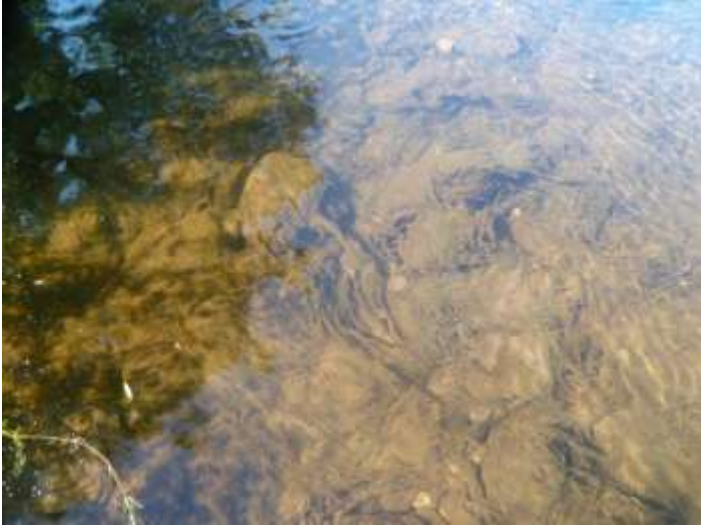
Diatoms:

Usually brown in colour, and doesn't have any sulphurous smell. It can vary from a thin brown film in rocks to heavy trailing growth as shown the picture above.

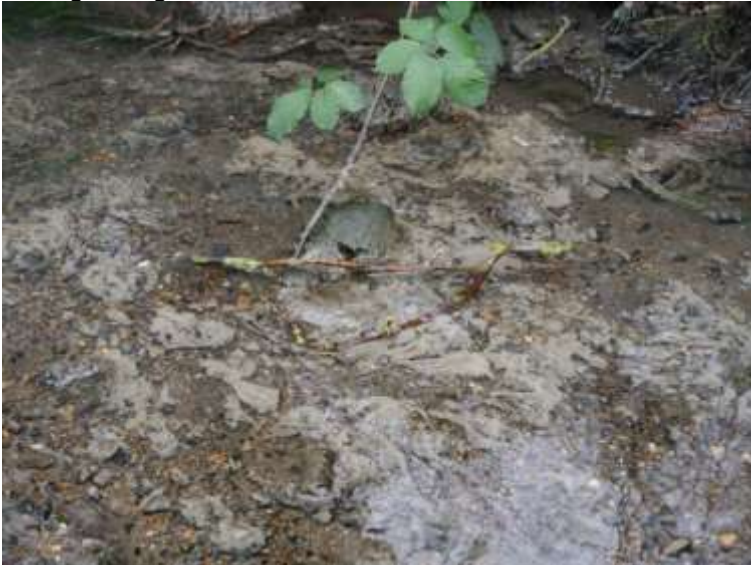
Sewage Fungus:

Usually grey or white clumps, and often has a strong odour.
